***KARIM TEXTILES LIMITED (9297)***  
*Noorbag, Kaliakoir, Gazipur*

## Fire SaFety FoL low up inSpection

<b>Factory Name</b>	KARIM TEXTILES LIMITED		
<b>Address</b>	Noorbag, Kaliakoir, Gazipur		
<b>Inspection Date</b>	04/05/2014		
<b>Date Report Received</b>	19/June/14		
<b>Date of 4th Follow-up</b>	31/July/16	<b>Date of 5th Follow-up</b>	09/October/16
<b>Date of 6th Follow-up</b>	08/December/16	<b>Date of 7th Follow-up</b>	22/December/16
<b>Inspected by</b>	NUSRAT HOSSAIN TRISHA

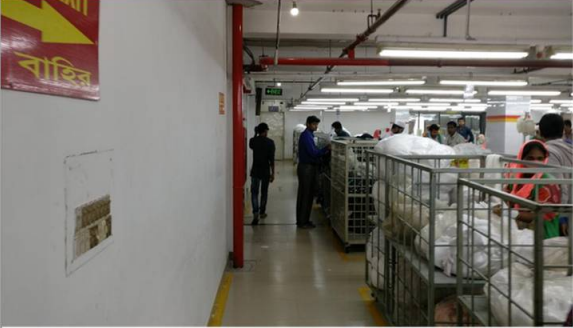
Item No	Accord Observation	Accord Recommendation	Timeline given by Accord	Comments after Physical Inspection	Supposed to complete(D D/MM/YY YY)	Status on the date of Inspection	Pictorial Evidence
3	Areas used for combustible storage are not separated by fire-rated construction. 6th and ground floor store rooms.	Provide dedicated storage rooms separated by minimum 1-hr fire-rated construction. Where separate storage rooms are not feasible, provide defined storage areas and limit the storage arrangement as follows: - Maximum height of 2.4m and maximum area of 23m2 - If sprinkler protected: maximum height of 3.66m and maximum area of 93m2 Separate areas of unenclosed combustible storage by a minimum clear distance of 3m.	Within 03 months	On 09/10/2016: Storage area without fire separation has been found besides dining on 7th floor and cutting floor.  On 08/12/2016: In process storage on 5th floor in new extension building that is open to production space in main building, neither met dimension for fire separation nor was fire separated.  On 22/12/2016: Corrected. Defined storage area has been maintained & sprinkler system was found active & proper.	12/06/2016	Corrected

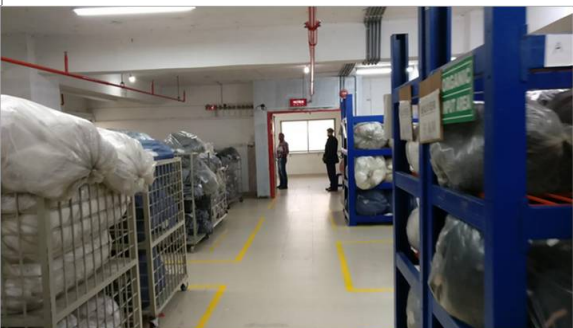
4	Common path of egress travel exceeds 30 m. 6th floor and ground floor store rooms.	Reconfigure the egress arrangement to reduce the maximum common path of travel to not more than 30 m.	Within 03 months	On 09/10/2016: Corrected. On 08/12/2016: Issue was corrected before. On 22/12/2016: Corrected	30/05/2014	Corrected

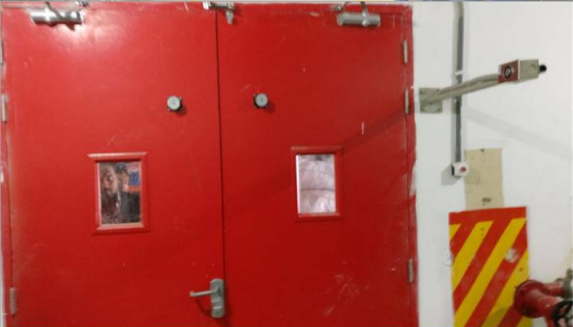
5	Collapsible gates / sliding doors are provided at building exits, and exit stairs. Sliding gates at many egress stairs.	Replace all gates / sliding doors along the means of egress with side-hinged, swinging egress doors. If locks are required for security reasons, utilize special door locking features complying with NFPA 101.	Within 03 months	On 09/10/2016: Corrected. Noncompliant door or gate has not been found during follow up inspection. On 08/12/2016: Corrected. Non-compliant door or gate was not seen during follow-up inspection. On 22/12/2016: Corrected	15/12/2014	Corrected

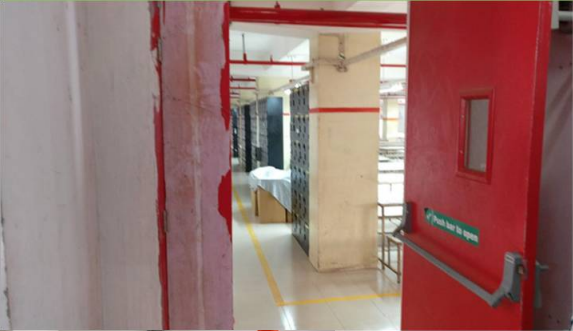
Item No	Accord Observation	Accord Recommendation	Timeline given by Accord	Comments after Physical Inspection	Supposed to complete(D D/MM/YY YY)	Status on the date of Inspection	Pictorial Evidence
6	Egress doors / gates with locking features are provided at building exits, and exit stairs. Pad locks on doors were unlocked and open at time of inspection.	Remove locking features from all egress doors/gates. If locks are required for security reasons, utilize special door locking features complying with NFPA 101.	Within 03 months	On 09/10/2016: Corrected. Locking feature has not been found during follow up inspection. On 08/12/2016: Corrected. On 22/12/2016: Corrected	18/08/2014	Corrected

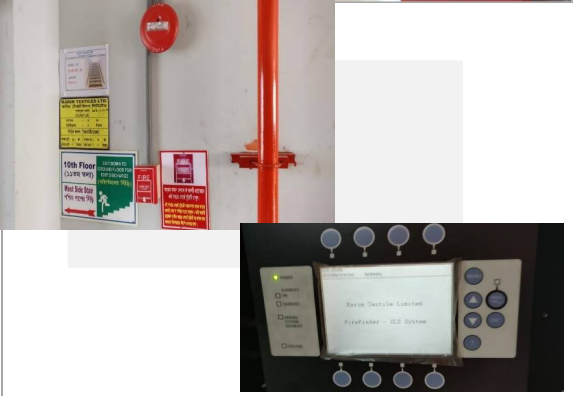
7	The fire alarm system is antiquated, not a listed system, and does not provide alarm and notification features consistent with acceptable standards.	Replace the fire alarm system with a new, listed addressable fire alarm system in accordance with NFPA 72.	Design within 4 months install within 9 months	On 08/12/2016: Factory reported that they have completed installation of fire alarm system system including interfacing and sent notification to ACCORD for testing & commissioning of the system. However, detectors and notification device were not seen in utility section. Also factory deviated from approved drawing by ACCORD- did not put detection devices where sprinkler was provided. During inspection original approval copy was not seen on site which is a primary condition for drawing approval. On 22/12/2016: Corrected. The fire alarm system has been checked & verified.	10/06/2016	Corrected

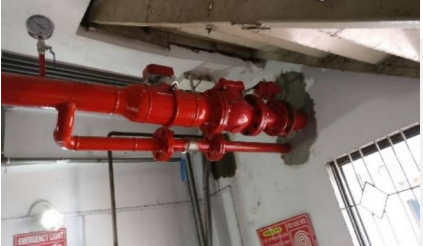
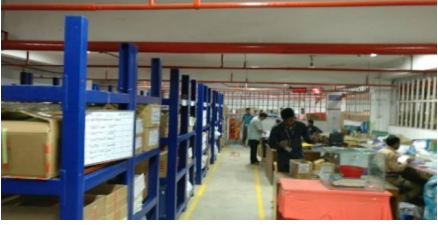
Item No	Accord Observation	Accord Recommendation	Timeline given by Accord	Comments after Physical Inspection	Supposed to complete(D D/MM/YY YY)	Status on the date of Inspection	Pictorial Evidence
8	The high-rise building has an occupied floor greater than 23m (75 ft) and is not provided with automatic sprinkler protection. The large occupant loads, heavy fuel loading, and anticipated extended egress times warrant sprinkler protection.	Provide automatic sprinkler protection throughout the building in accordance with NFPA 13.	Design within 6 months install within 12 months	<p>On 08/12/2016: Factory reported that they have completed installation of sprinkler system and sent notification to ACCORD for testing &amp; commissioning of the system. During inspection original approval copy was not seen on site which is a primary condition for drawing approval. Factory shall provide 2-hour rated fire separated for fire pump room with unobstructed rated access.</p> <p>On 22/12/2016: Corrected. The sprinkler system has been checked &amp; verified.</p>	31/07/2016	Corrected

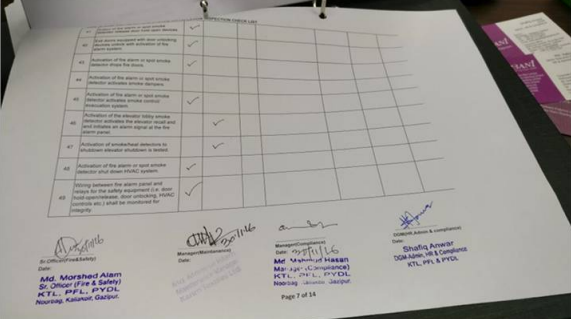
9	Inspection, testing, and maintenance records for the fire alarm system were not available.	Inspect, test and maintain the fire alarm system, and keep written records on-site, in accordance with NFPA 72.	Within 03 months	<p>On 09/10/2016: Corrected. The factory has maintained the checklist for the existing fire alarm system. It is required to update the checklist as per new installed system.</p> <p>On 08/12/2016: Corrected.</p> <p>On 22/12/2016: Corrected</p>	17/03/2016	Corrected

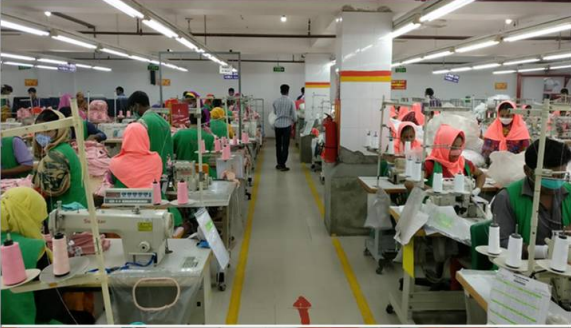
Item No	Accord Observation	Accord Recommendation	Timeline given by Accord	Comments after Physical Inspection	Supposed to complete(D D/MM/YY YY)	Status on the date of Inspection	Pictorial Evidence
19	New Finding: The width of egress aisles is less than 36-in.	Provide minimum aisle widths of 36-in.	Within 3 months	On 09/10/2016: The width of egress aisles is less than 36-inch has been found at 6th floor cutting section and several floors at iron & finishing area. On 08/12/2016: No action has been taken yet. Found same as previous follow-up. On 22/12/2016: Corrected.	31/10/2016	Corrected

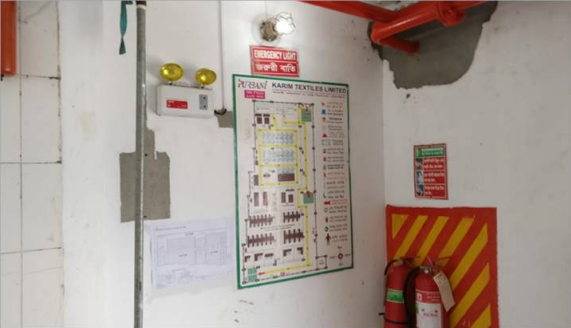
20	New Finding (5th follow up): There were multiple emergency lights and exit signage that has not sufficient "Emergency Backup Power" for each floor.	Provide emergency backup power for the emergency lightings and exit signage.	Immediate	On 09/10/2016: New Finding On 08/12/2016: No action has been taken yet. On 22/12/2016: Corrected	17/10/2016	Corrected

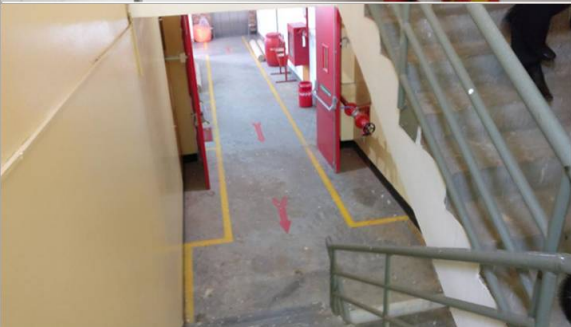
21	New Finding (5th follow up): Storage (rack and comustible fabrics) was located in the exit corridor on each floor.	Remove all storage from exit corridor and exit stairs.	Immediate	On 09/10/2016: New Finding On 08/12/2016: Corrected. On 22/12/2016: Corrected	12/10/2016	Corrected

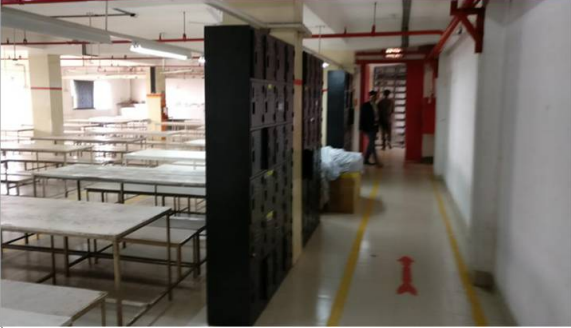
Item No	Accord Observation	Accord Recommendation	Timeline given by Accord	Comments after Physical Inspection	Supposed to complete(D D/MM/YY YY)	Status on the date of Inspection	Pictorial Evidence
22	Exit capacity (850 persons) is not adequate for the occupant load (640 persons, as per initial report) at dining on 7th floor	1. Reduce occupant load to not more than available exit capacity. Or 2. Provide additional exits to increase exit capacity.	Immediate	On 08/12/2016: No action has been taken yet. Factory has provided 3rd exit for dining space through work area in new extension building which is a different occupancy.  On 22/12/2016: Corrected. Factory has reduced occupant load, reduced sitting arrangement from dining area.	17/10/2016	Corrected
